# **INDOOR AIR QUALITY ASSESSMENT**

**L.D. Batchelder Elementary School  
2 Peabody Street  
North Reading, Massachusetts**

Prepared by:  
Massachusetts Department of Public Health  
Bureau of Environmental Health Assessment  
March, 2001

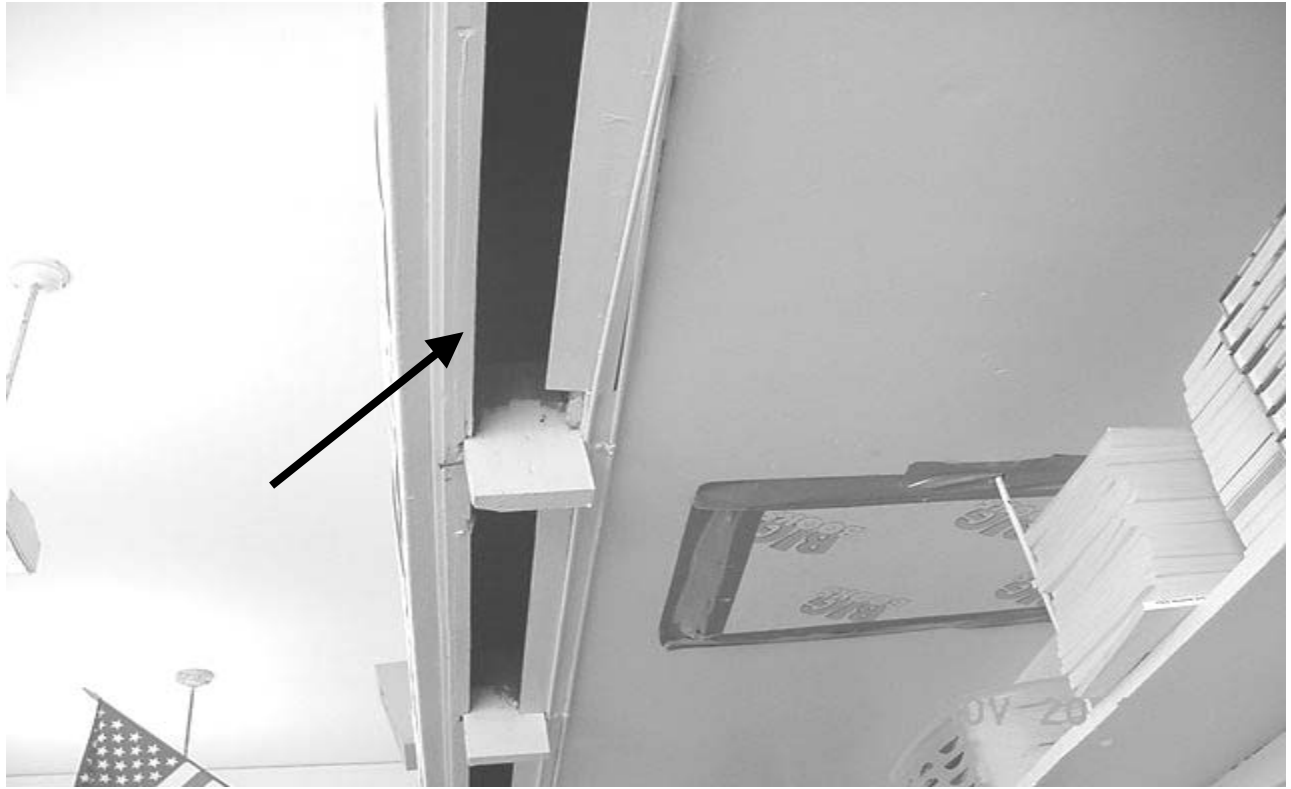
**Picture 23**

Several other conditions were noted during the assessment that can affect indoor air quality. Abandoned exhaust ducts stuffed with a fiberglass material were noted in the coat closets of some classrooms. If these vents are not properly sealed on the roof, backdrafting can occur which can aerosolize fibers. The coat closet to classroom 5 was open to the attic, which contains loose fiberglass insulation (see Picture 23). Fiberglass insulation can be a source of skin, eye and respiratory irritation to sensitive individuals.

**Space in Coat Closet Open to the Attic Containing Fiberglass Insulation**

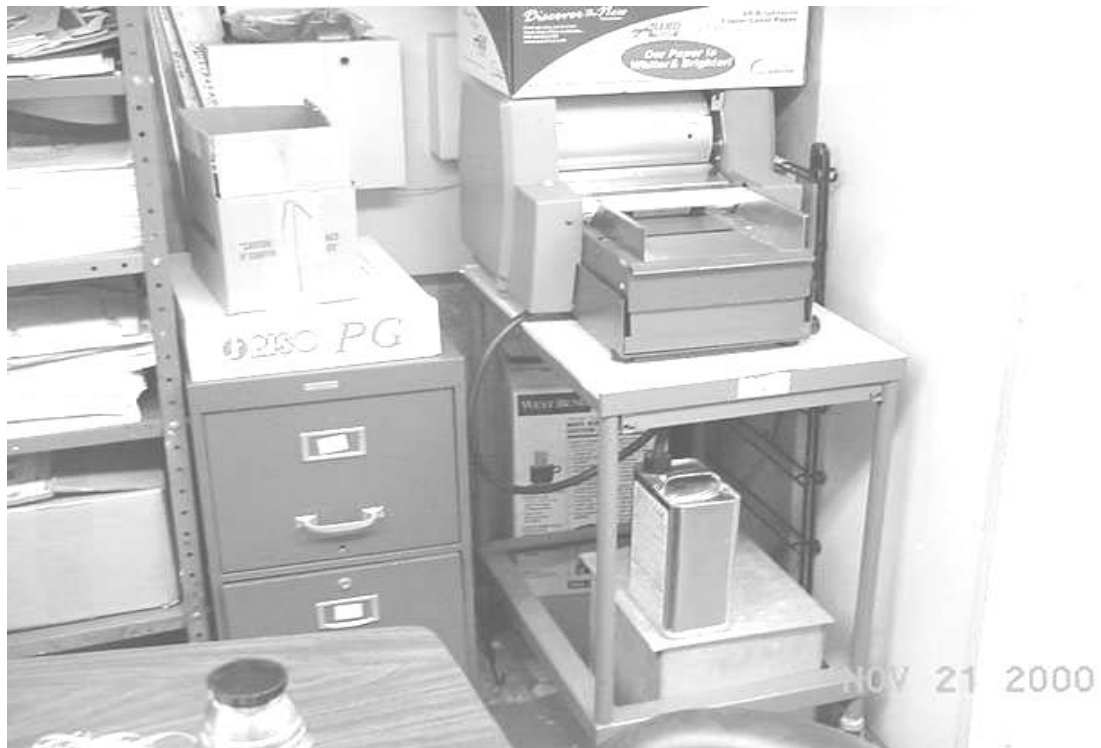
Picture 24

The paraprofessional's office contained two lamination machines, a rizzograph photocopier, a mimeograph machine and several containers of duplicating fluid (see Picture 24). Volatile organic compounds (VOCs) and ozone can be produced by

photocopiers, particularly if the equipment is older and in frequent use. Ozone is a respiratory irritant (Schmidt Etkin, D., 1992). Lamination machines can produce irritating odors during use. Mimeograph duplicating fluid contains methanol (methyl alcohol), which is a VOC that readily evaporates at room temperature. The off gassing of this material can be irritating to the eyes, nose and throat. Methanol is also a highly flammable material, which can be ignited by either flame or electrical source. This area is not equipped with mechanical ventilation to dilute and remove excess heat and odors generated by office equipment.

**Mimeograph Machine and Flammable Duplicating Fluid**

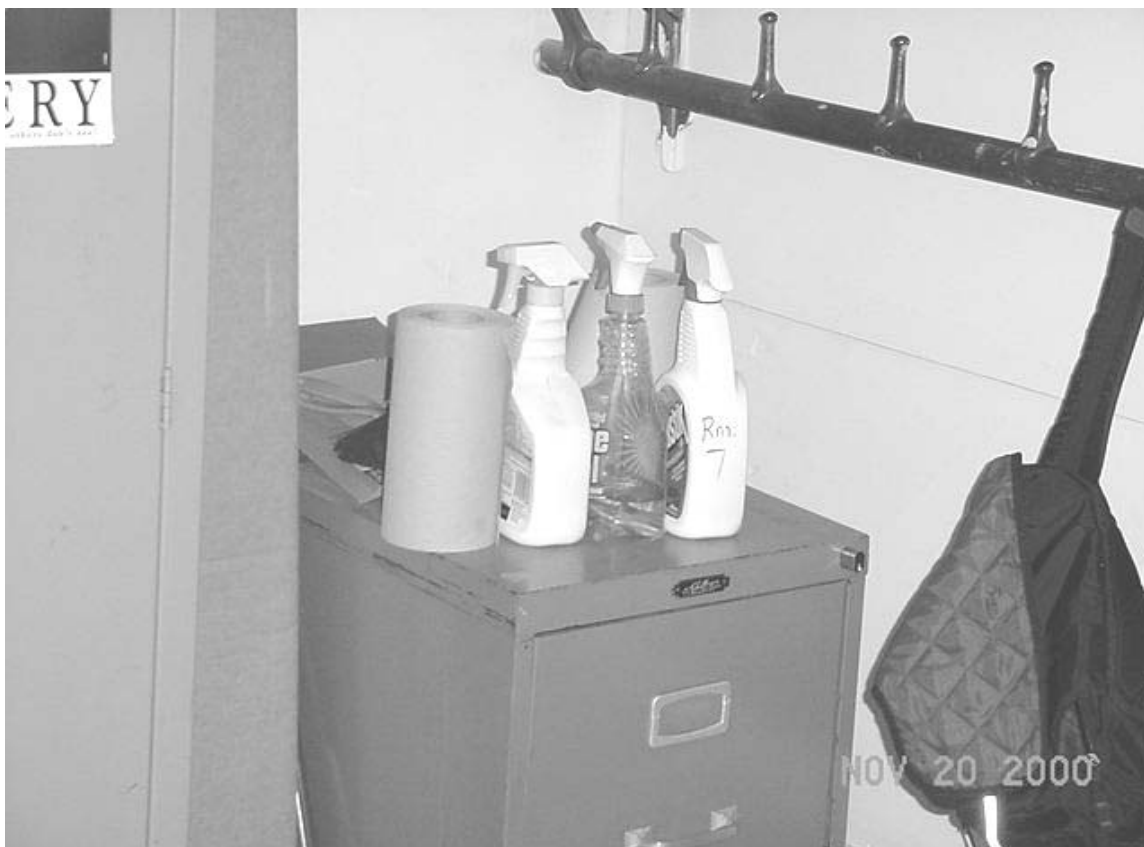
**Picture 25**

Several classrooms contained dry erase boards and dry erase board markers. Materials such as dry erase markers and dry erase board cleaners contain VOCs, such as isopropyl alcohol and butyl-cellusolve. Cleaning products were found on counter-tops and beneath sinks in a number of classrooms (see Picture 25). Cleaning products and dry erase board markers and cleaners contain chemicals that can be irritating to the eyes, nose and throat of sensitive individuals.

**Spray Cleaning Products in Classroom**

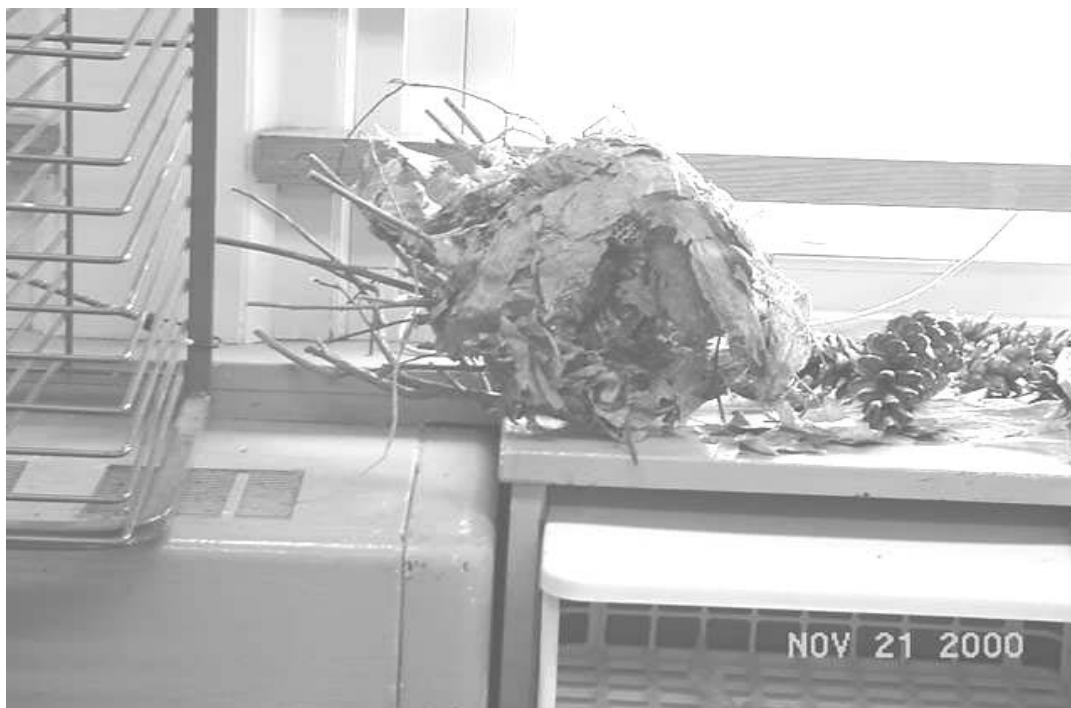
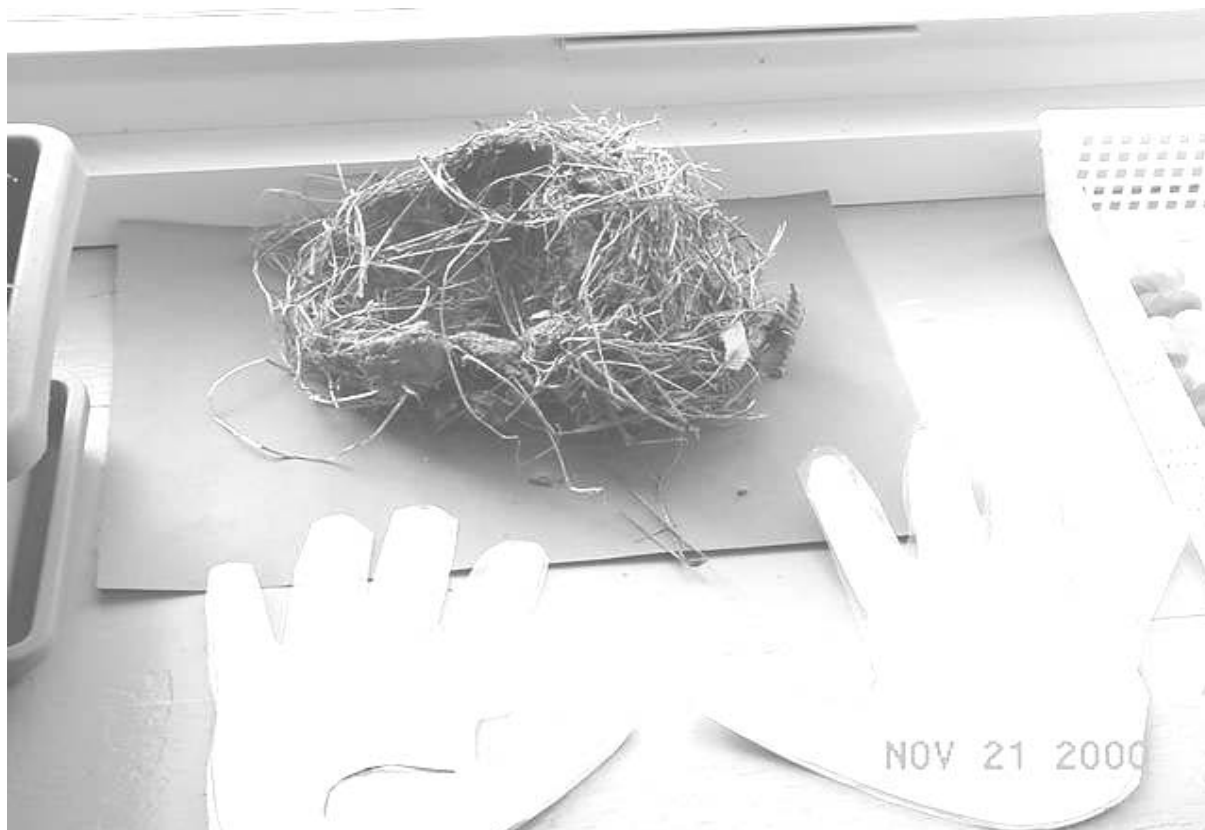
Inactive wasp's nests and bird's nests were noted in classrooms, which serve as learning tools (see Pictures 26 & 27). Insect parts can become dried out and aerosolized and may serve as a source of allergenic material for certain sensitive individuals. Bird's nests can contain bacteria and may also be a source of allergenic material. These items should be located away from univents to prevent the aerosolization of insect parts and/or allergenic material.

**Inactive Wasp's Nest in Classroom near Univent**

**Bird's Nest in Classroom**
